Intermodal Logistics Park North (ILPN) Strategic Rail Freight Interchange (SRFI)

Appendix 15.3: Ground Investigation Report (Land West of Parkside Road) (Part 01 of 02)

Phase 2 Site Investigation

Parkside East, St Helens

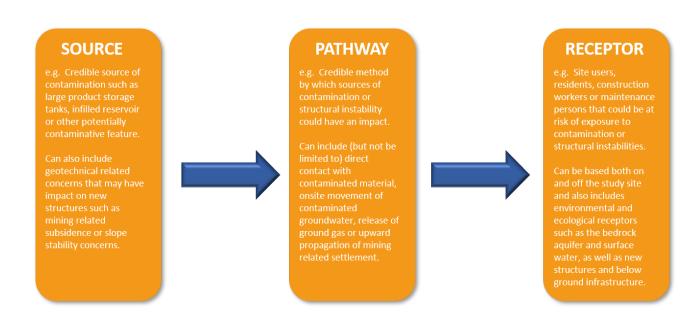
Figure 8.0 Source Pathway Receptor Diagram

- 8.0.3 In accordance with this method, a Refined Conceptual Model has been collated for the site based on the results of the desktop review. This model is based around the Source / Pathway / Receptor methodology as outlined in Fig 8.0.

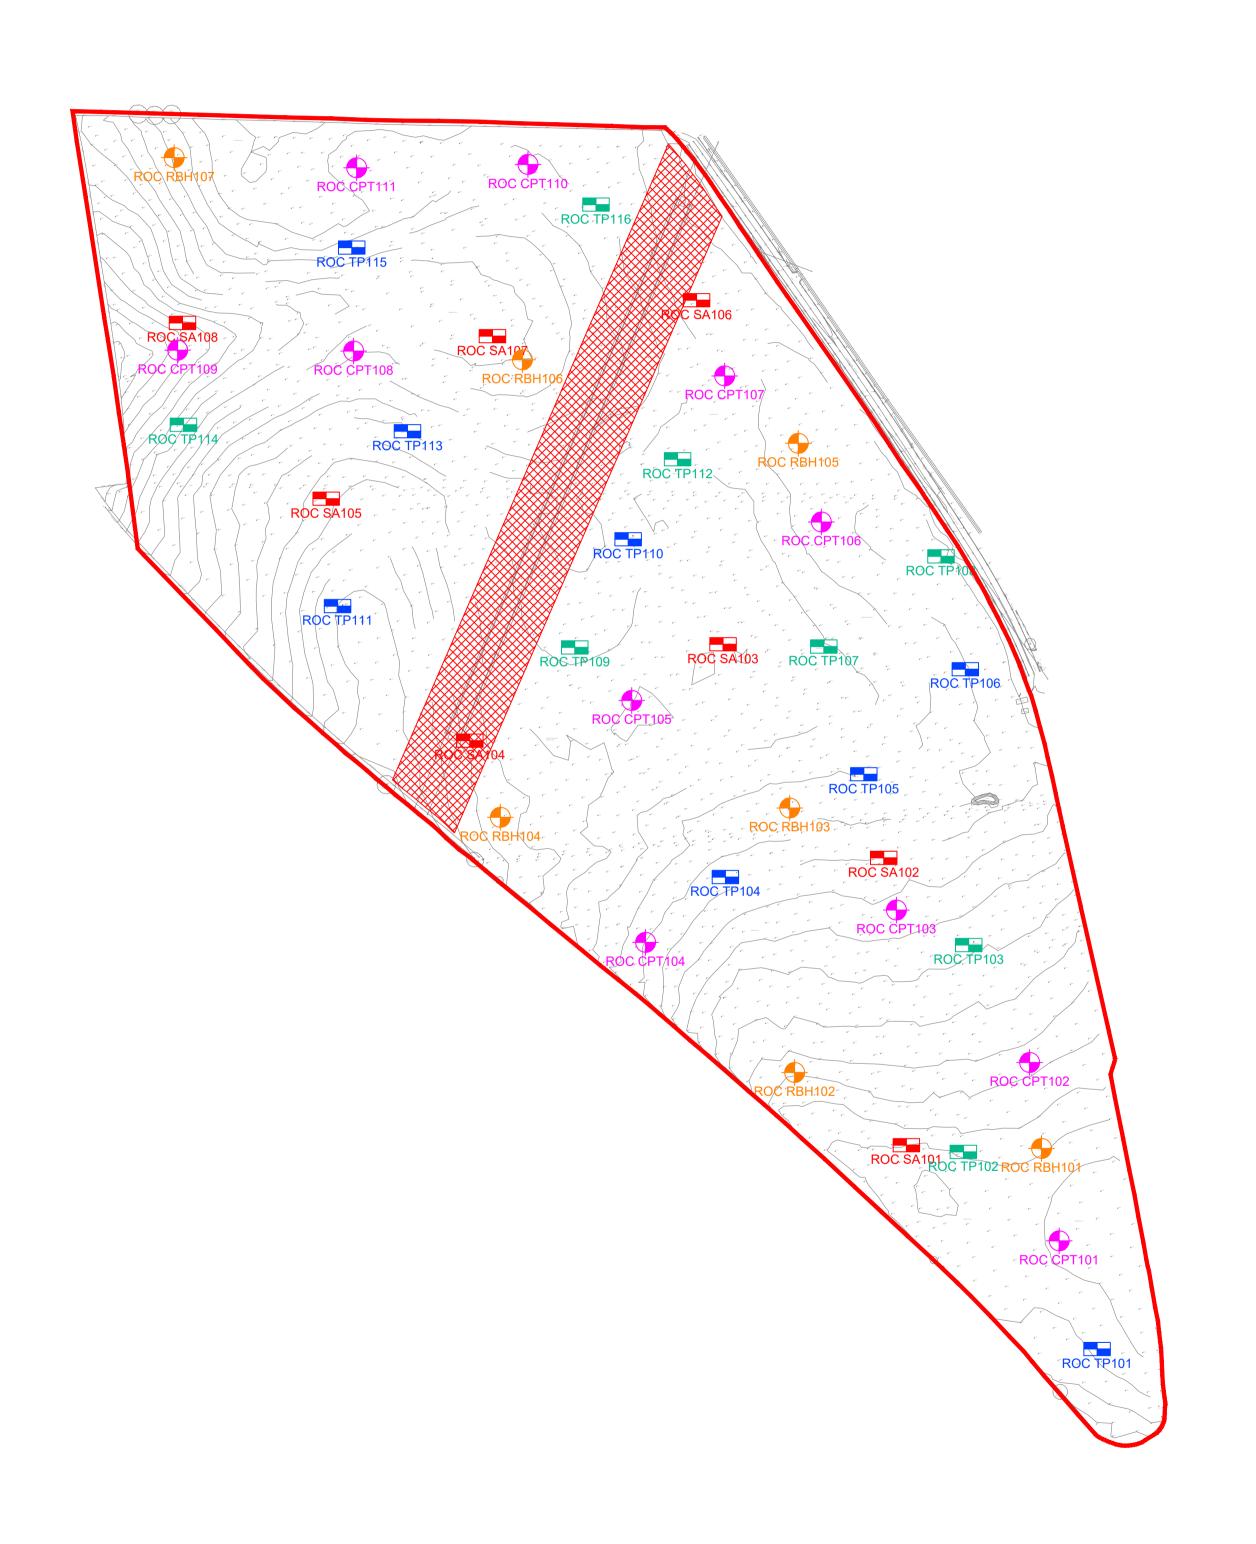
4597-ROC-ZZ-XX-DR-ES-ES102

SITE INVESTIGATION LAYOUT PLAN (PROPOSED)

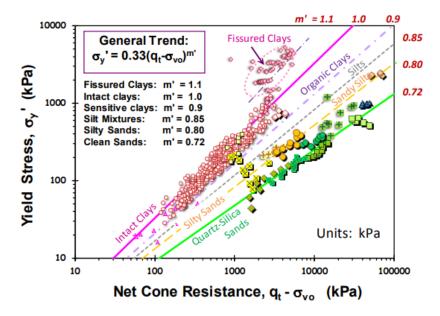
Figure 5-6 Preconsolidation stress with net cone resistance power law, reproduced from Mayne (2014).

An additional set of σ_p' and OCR values were calculated for m'=1.1 to reflect the upper trend for over consolidated fissured clays not captured by the correlation with I_c .

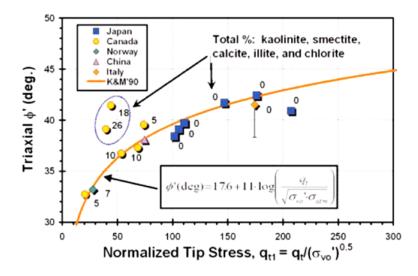
Figure 5-7 Peak triaxial friction angle from undisturbed sands with normalised cone resistance.

The presence of compressible minerals tends to reduce tip resistance resulting in lower estimate of friction angle, while very coarse (sand) or larger grain size tends to increase tip resistance resulting in higher estimate. Increased penetration resistance due to high k_0 conditions also results in an overestimate of friction angle.

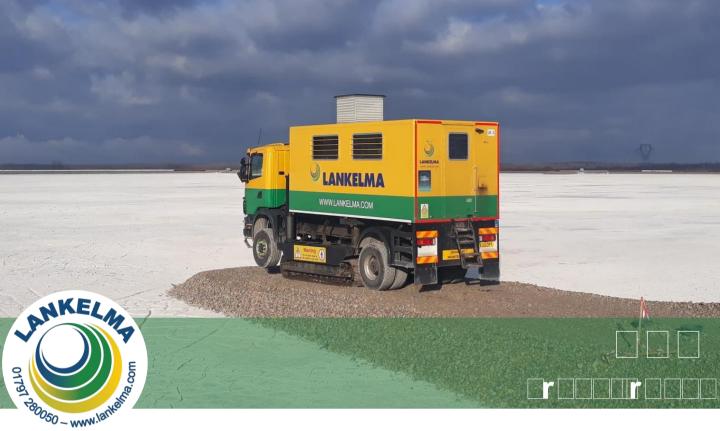
20.5 T 17 T M ----r 86 km/h oracan aarma Steel oracomoca) 3300 mm eranam dana 650 mm Tracks act as jacks ______ 1nr. on each side M a mira a d mara a a a 210 mm M a mraad marma Tracking/pushing - 47 kPa Pulling – 88 kPa _r____r_ M10 degrees M ----r 20 degrees (operator assessed) Testing - 74 dBA Driving - 87 dBA 36/55 push-pull clamp 1.2 m 55 mm

Lankelma's versatile track-truck is suitable for most geotechnical sites. The rig is driven to site as a self-contained HGV with tracks that can be deployed to cope with soft or uneven terrain. Fitted with a chalwyn valve and spark arrestor.
