INTERMODAL LOGISTICS PARK NORTH (ILPN)

Project reference TR510001

Preliminary Environmental Information Report (PEIR)

Arboricultural Impact Assessment

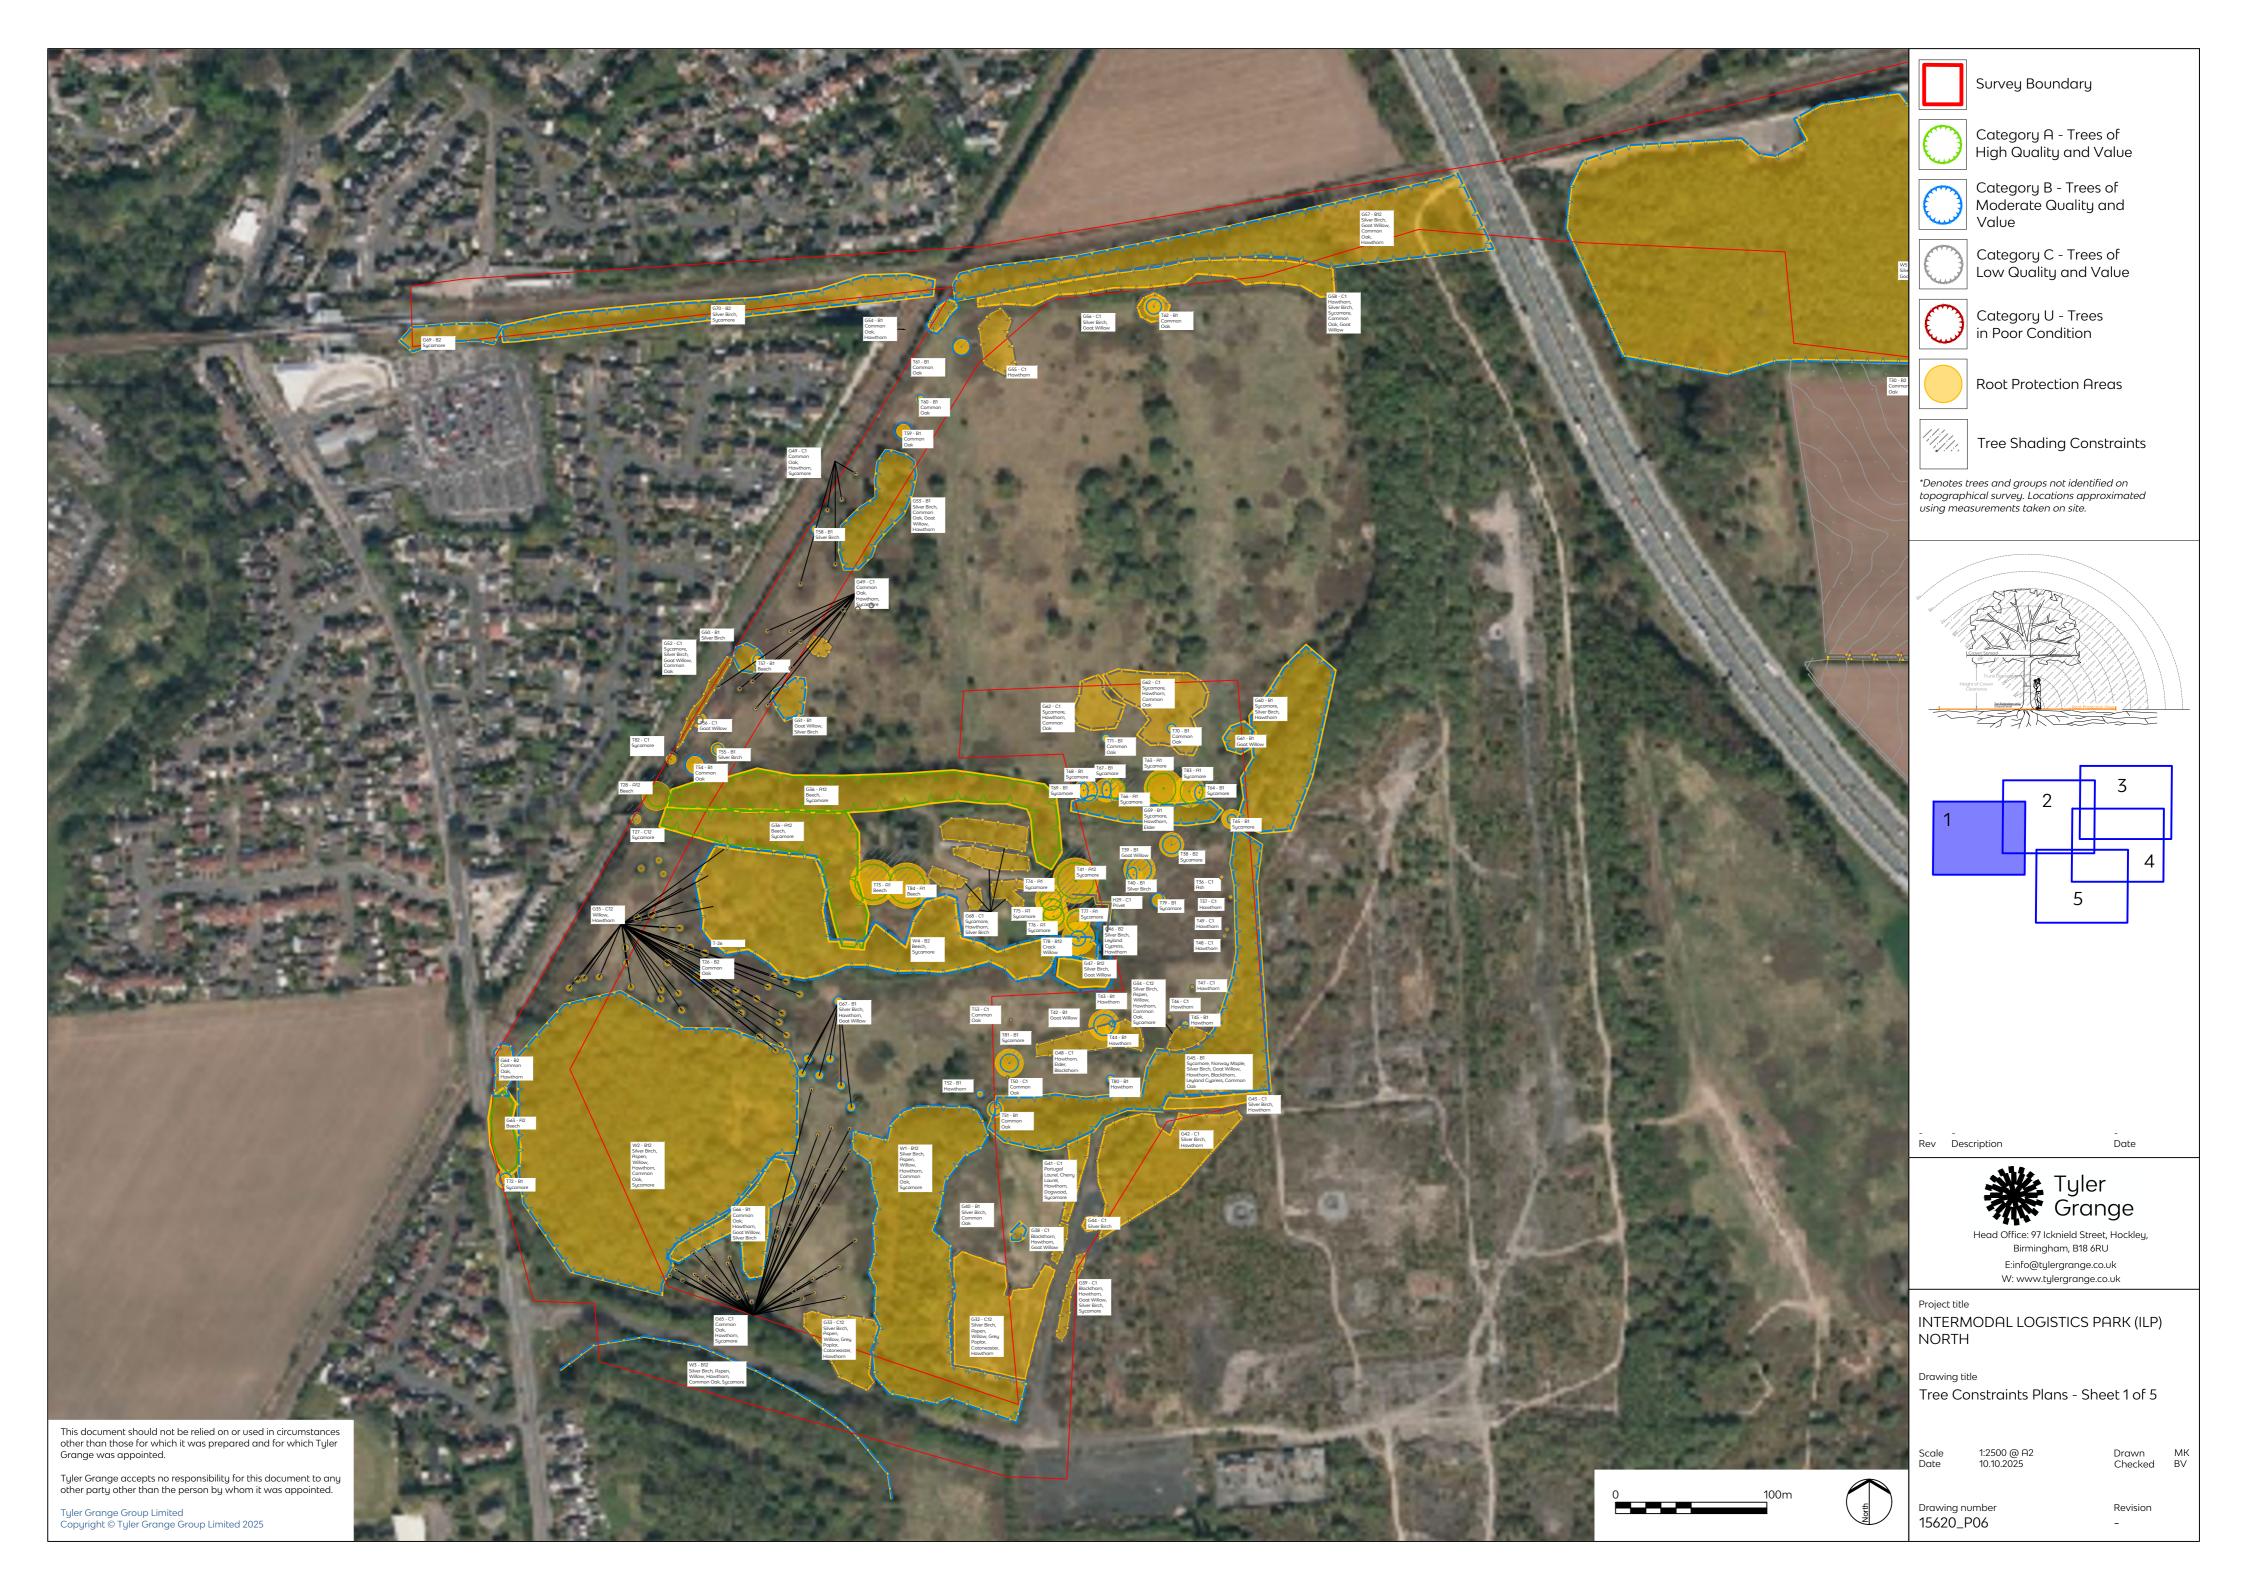
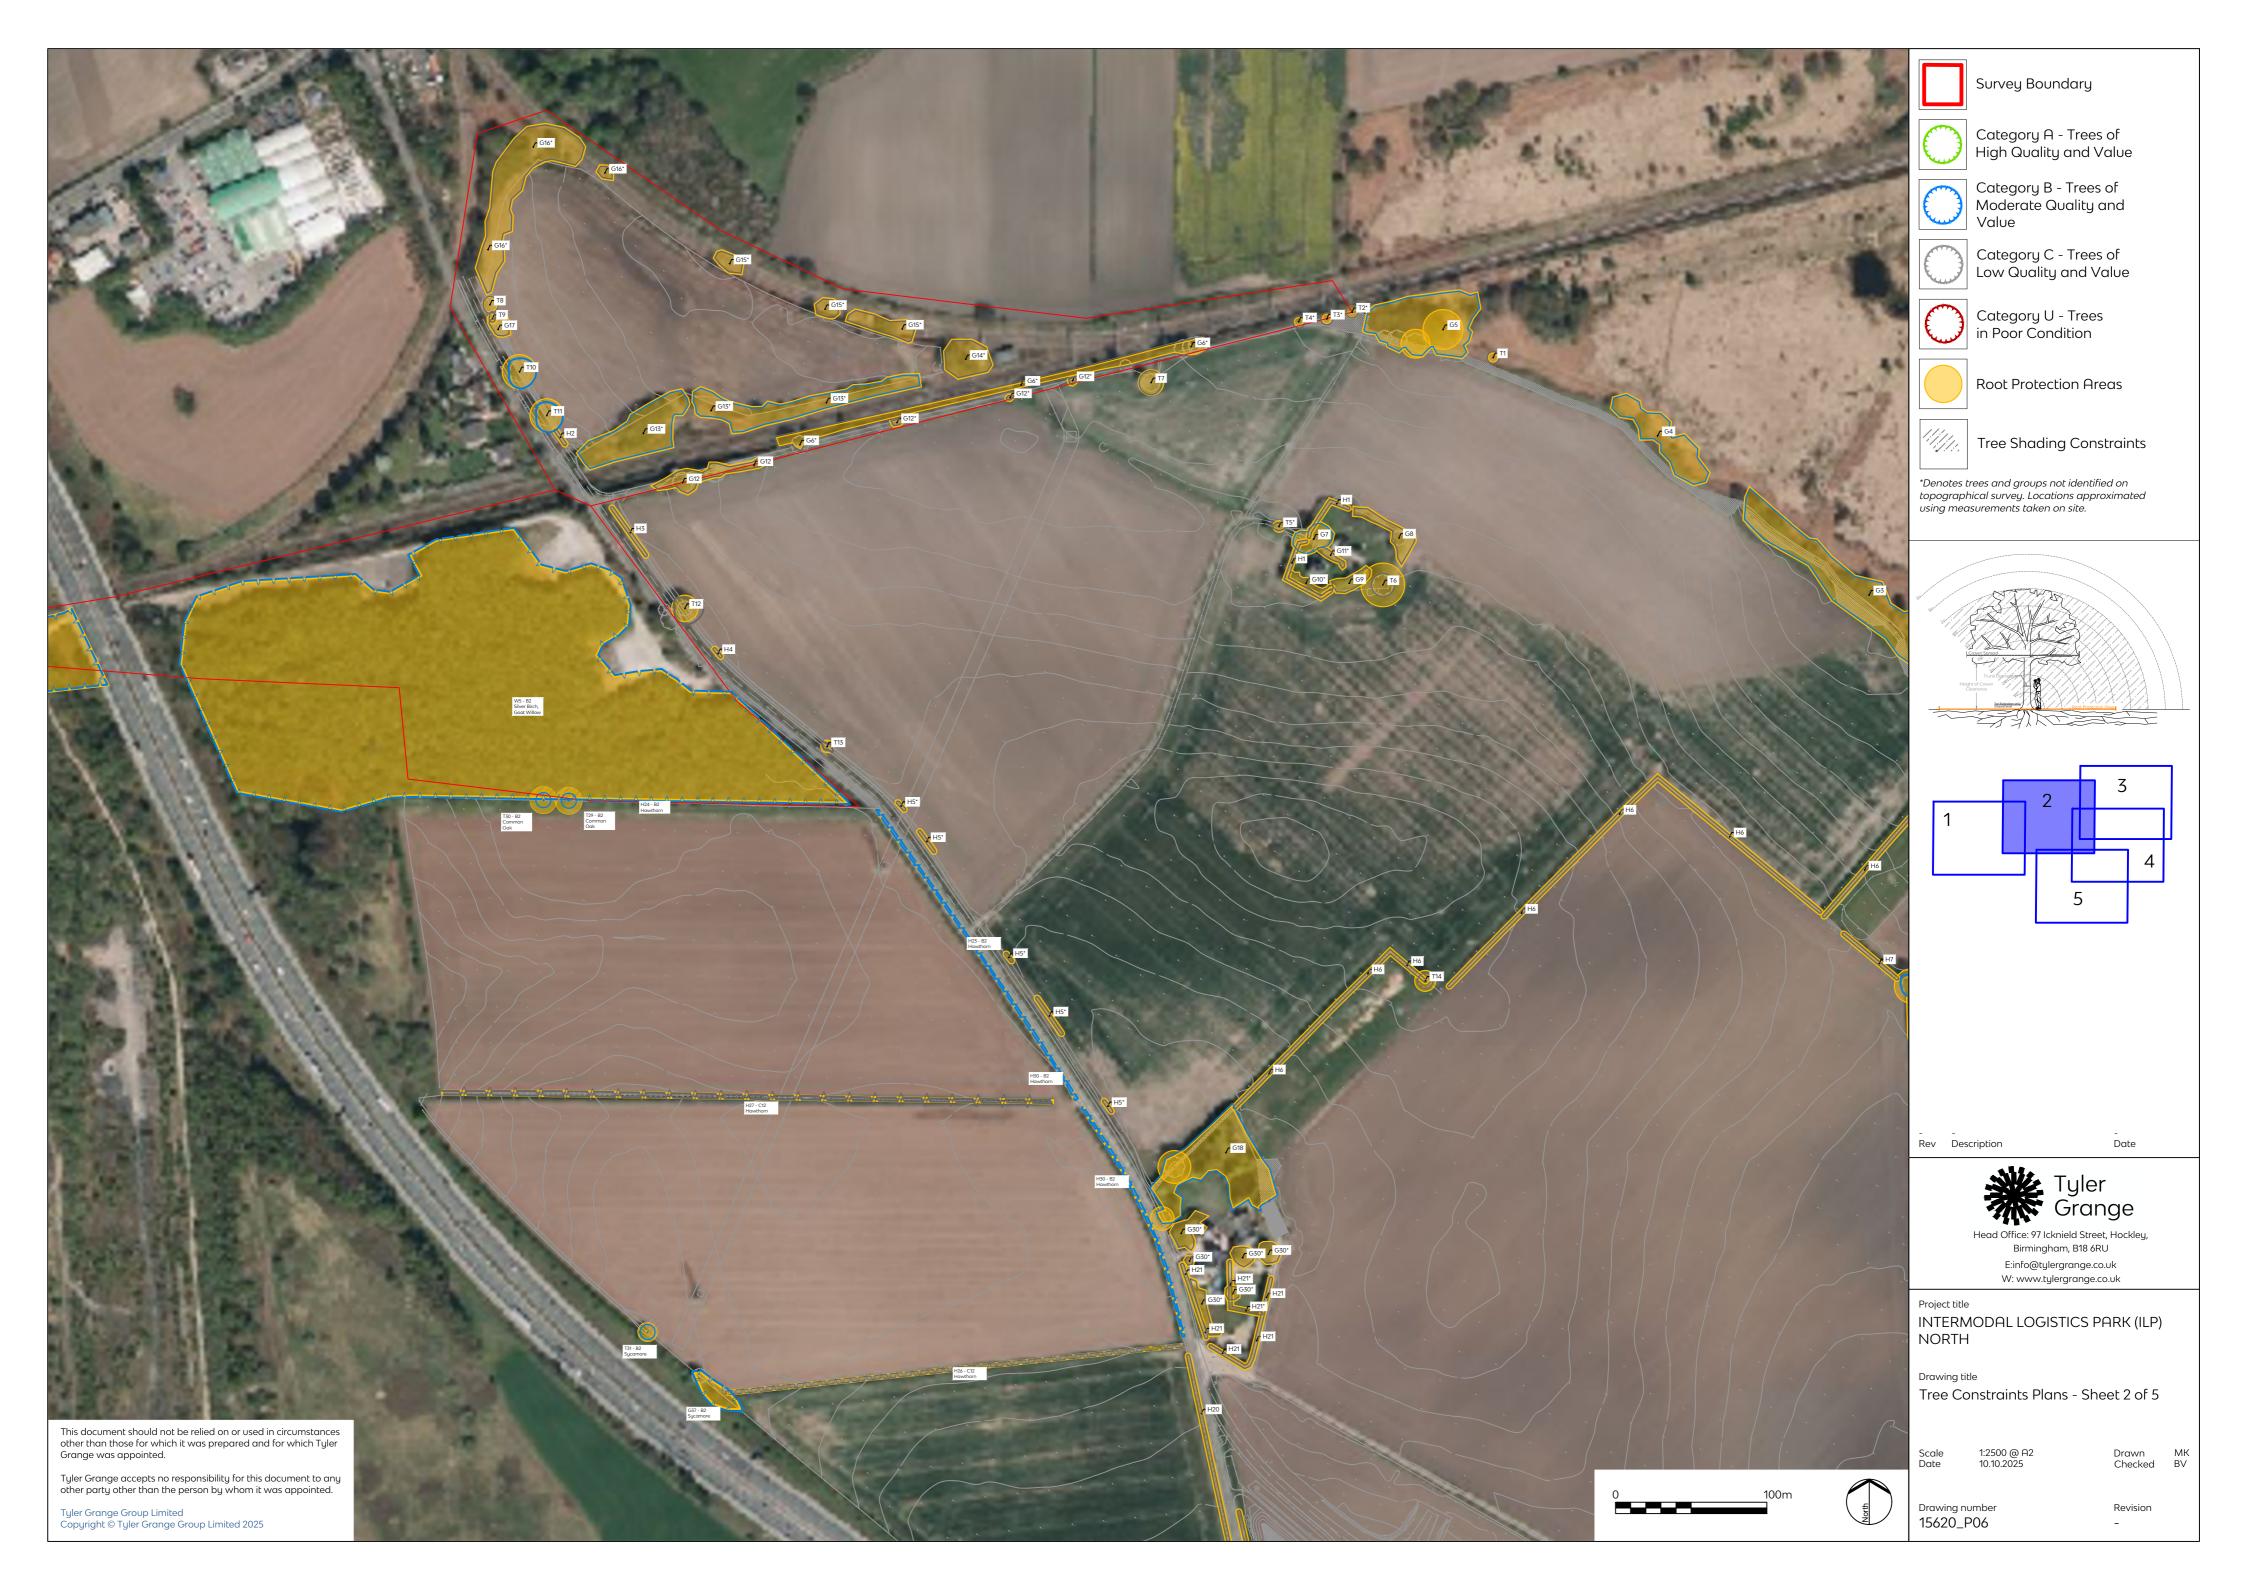
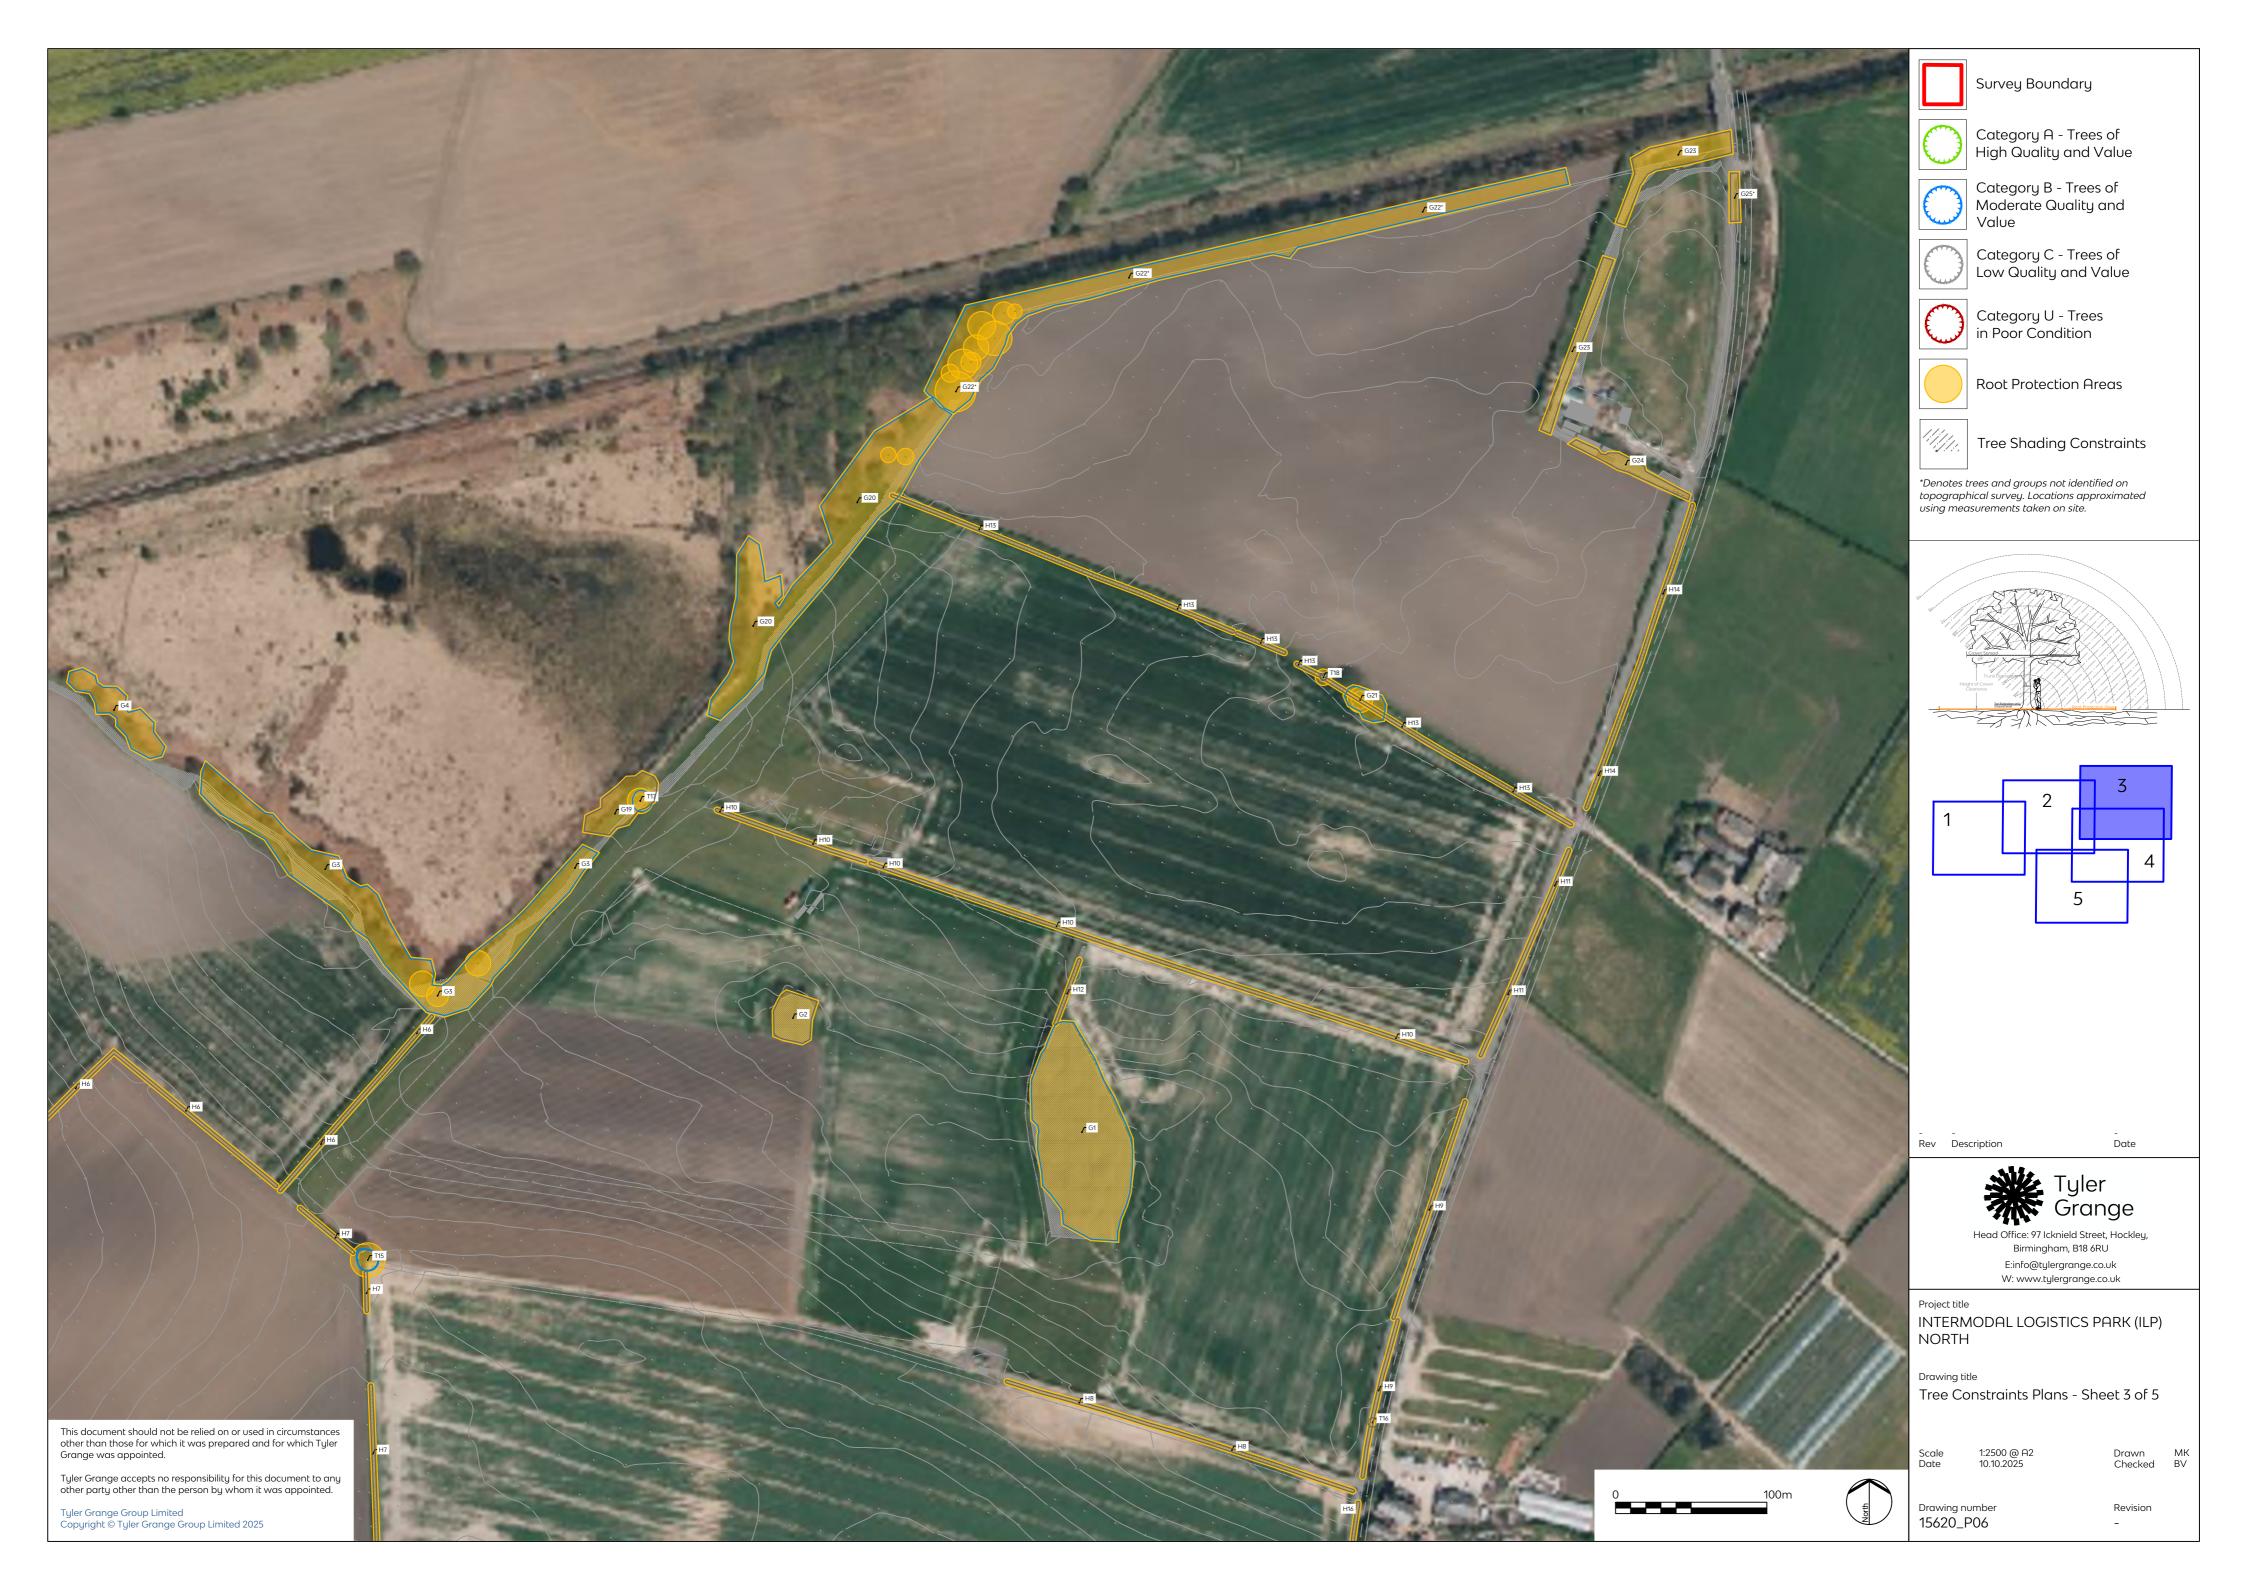
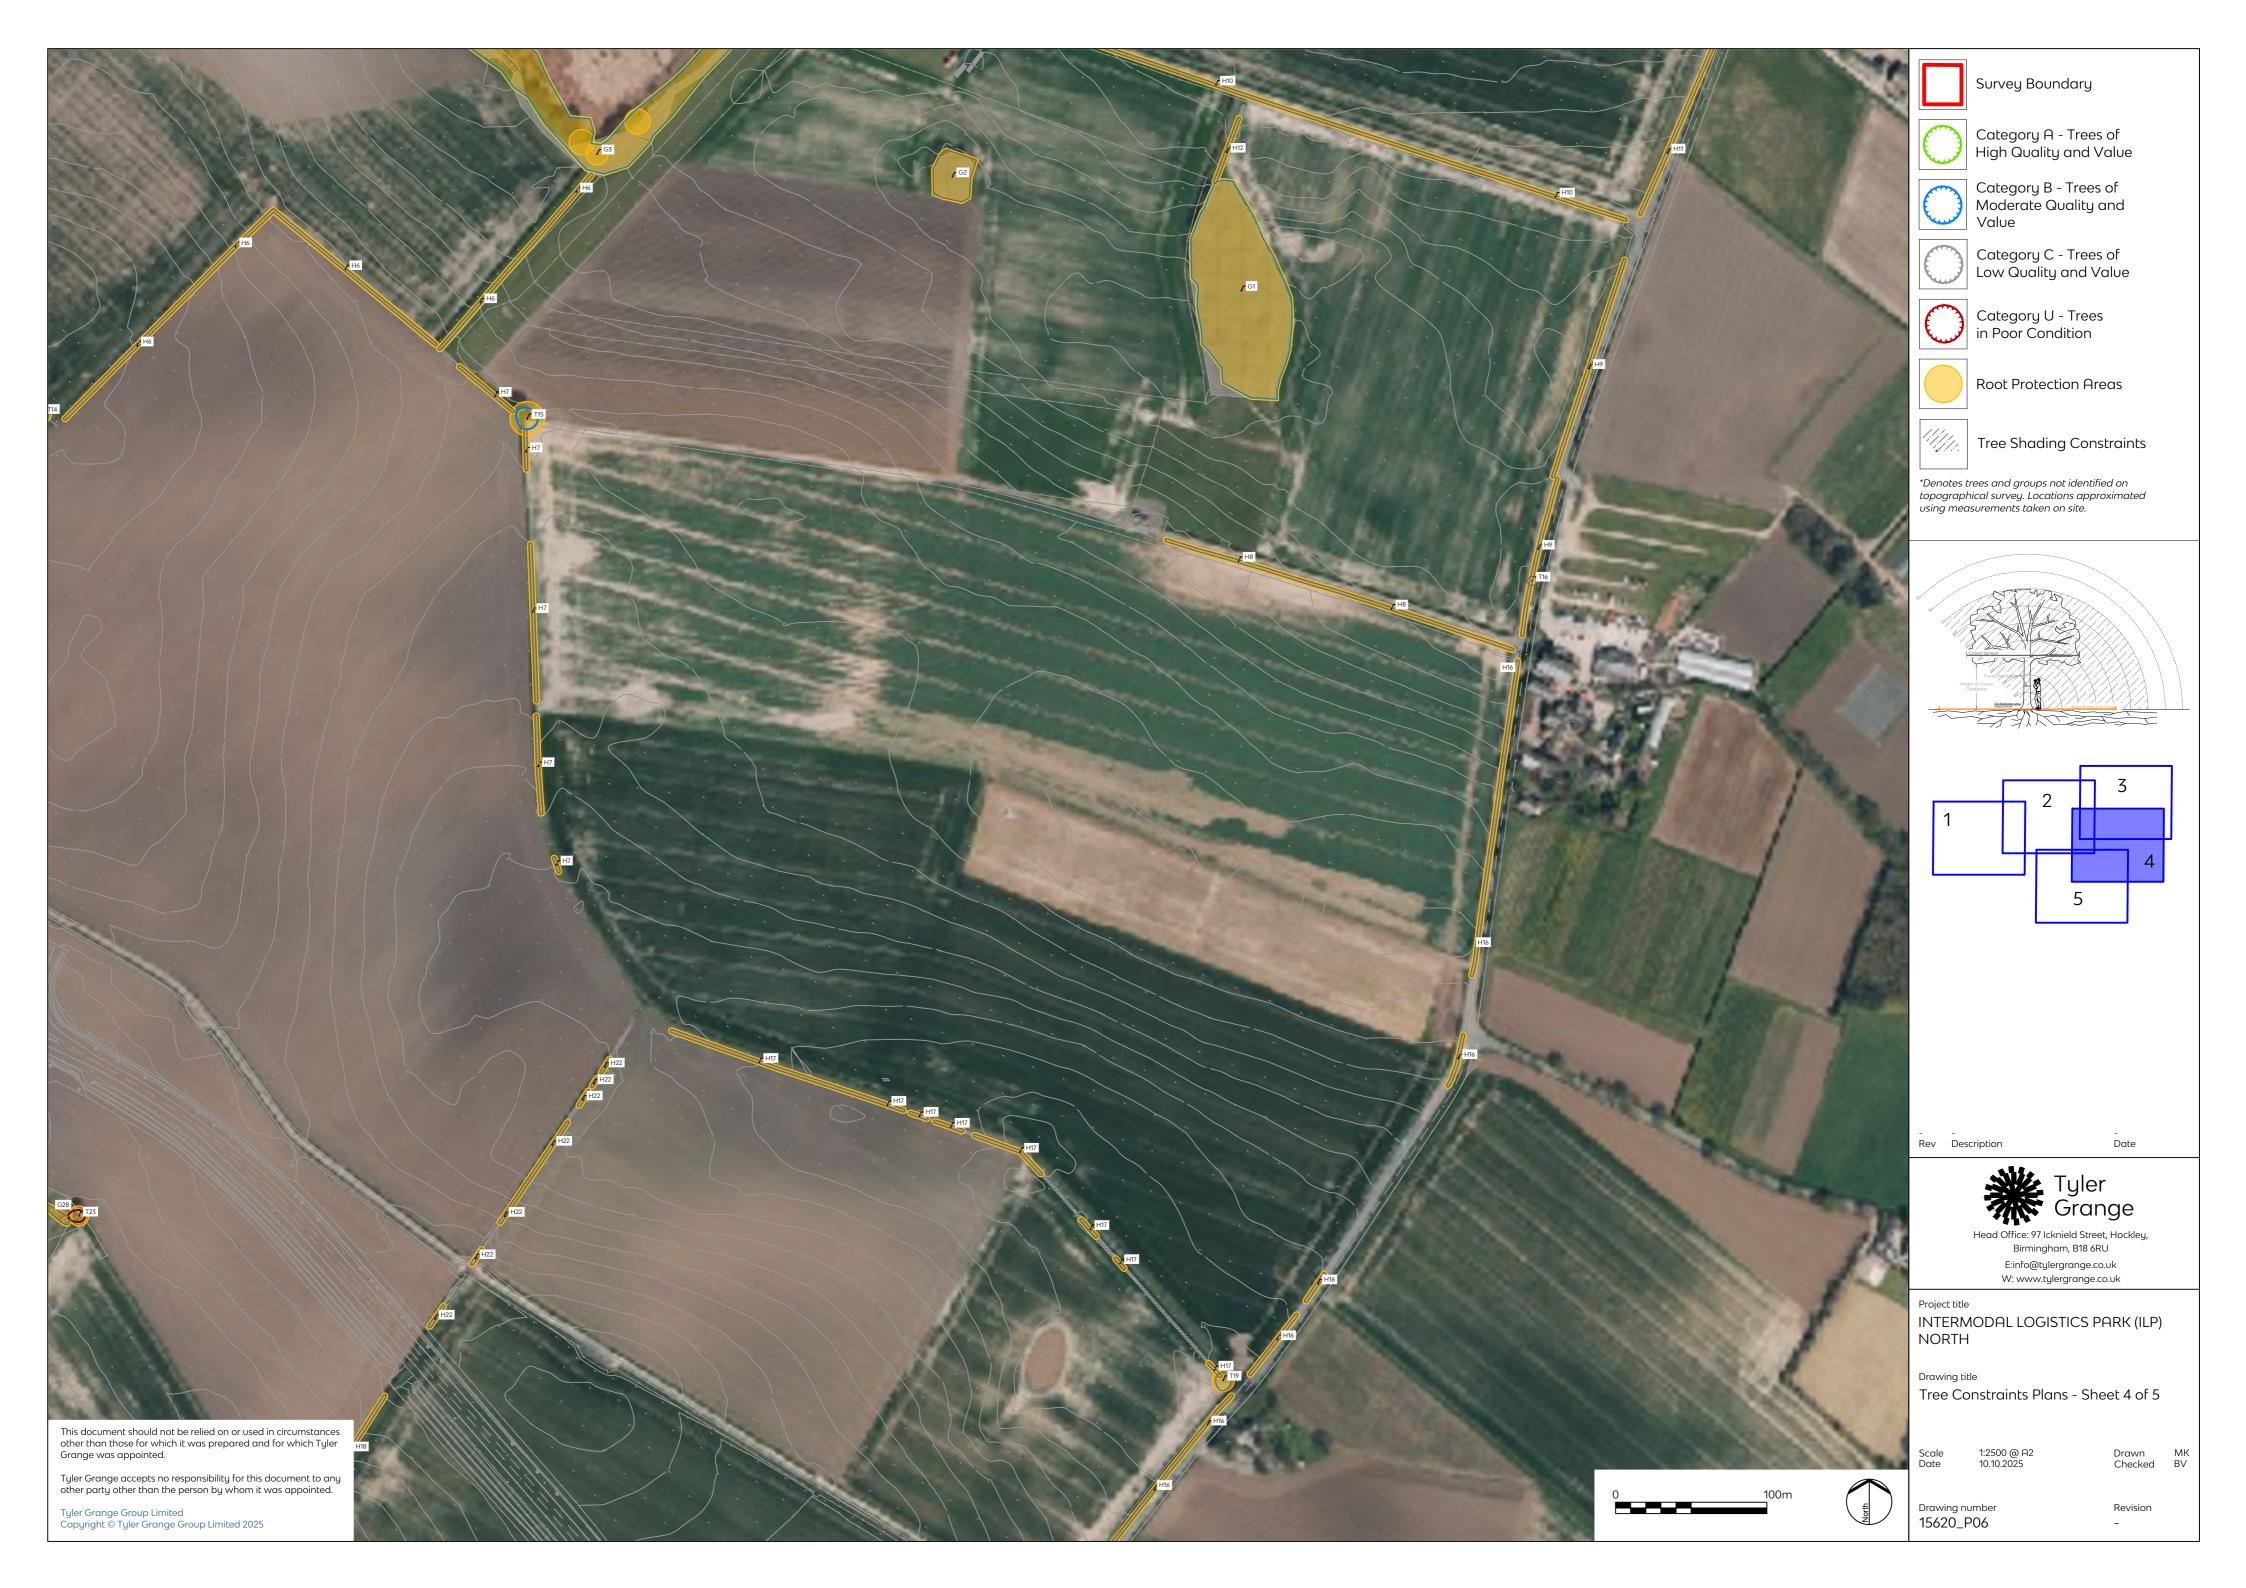
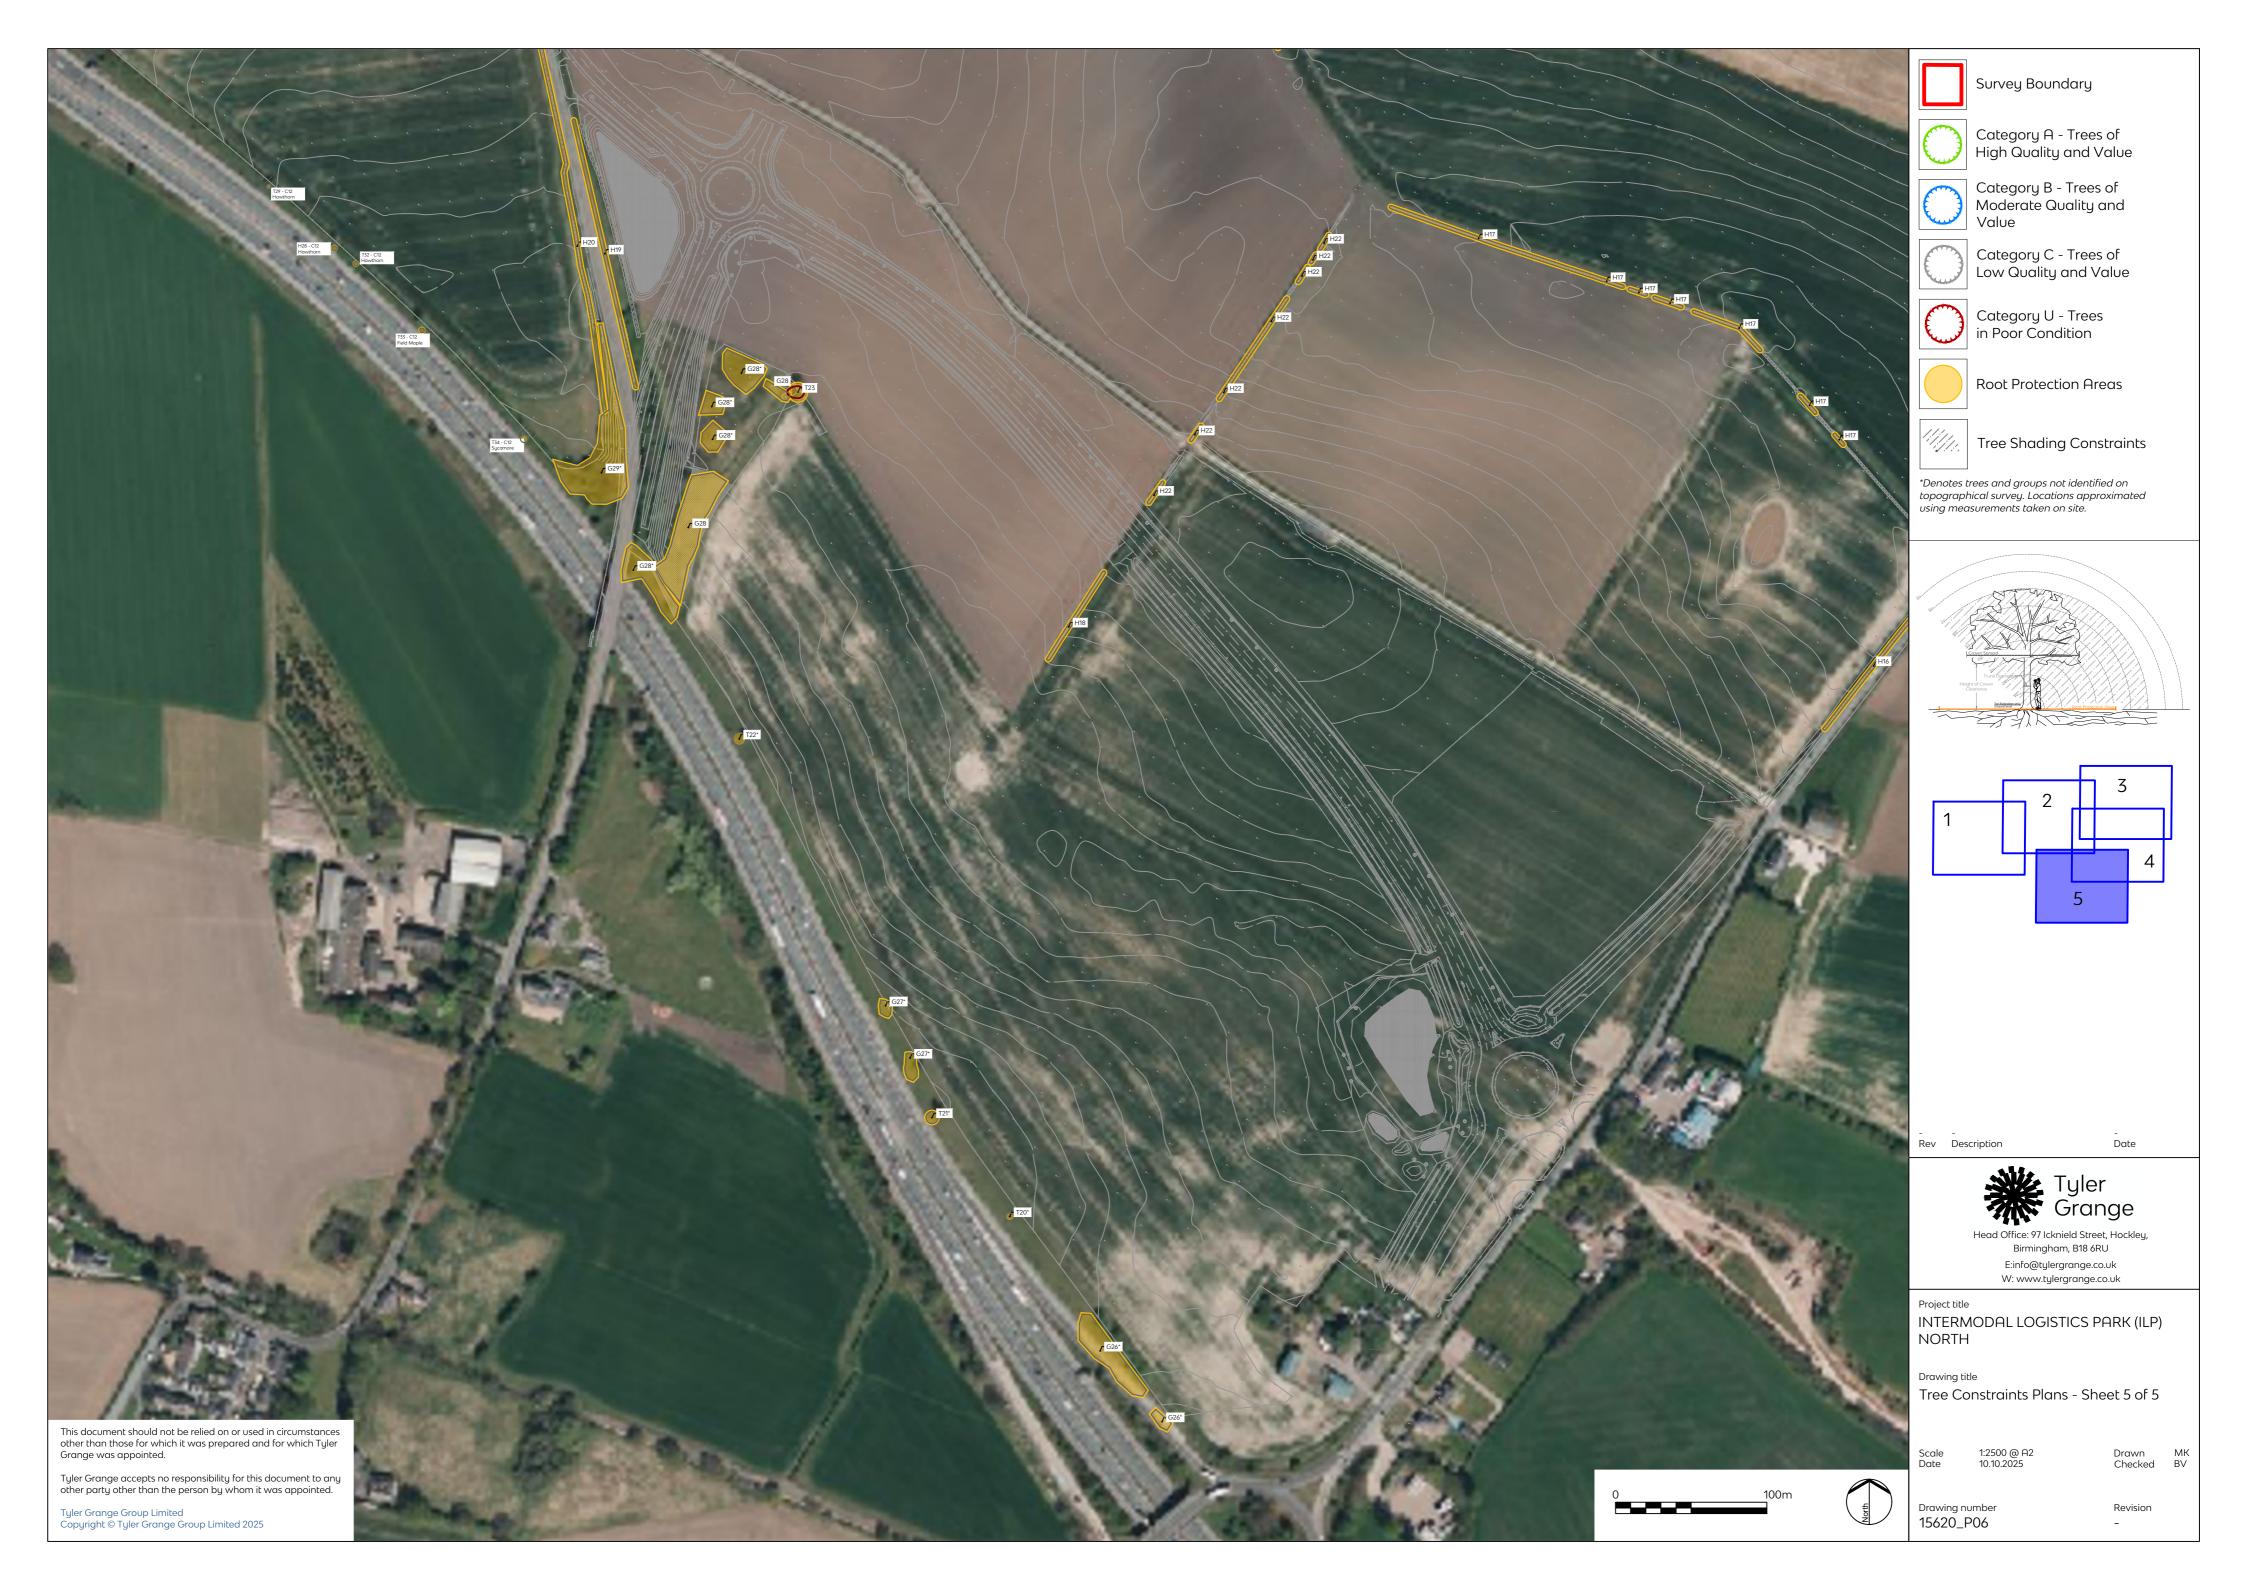
Tree Constraints Plan
Tree Retention and Removal Plan

- 1.1. The site is centred on national grid reference TQ 360385, 395340 and its boundary is demarcated by the red line as shown in the Tree Constraints Plan, Appendix 4.
